SAWMILL FORUM

CASEY
CREAMER

SAW
DOCTOR

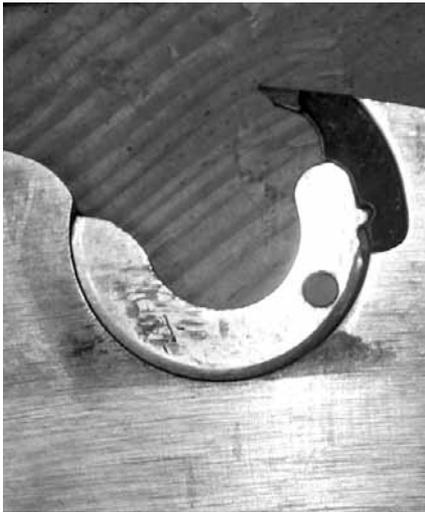
Regular bit with winter shank.

Picture 1. shows the regular bit and winter shank combination. Picture 2. shows the regular shank and winter bit combination. Picture 3. shows the unwanted winter bit and winter shank combination.

The idea of the combinations in the first two pictures is that when you are sawing frozen logs, you don't want a perfectly round gullet area. What you want is a protrusion into that gullet area that will prevent the frozen sawdust from swirling around and around in the gullet because it is that swirling action that tends to break the frozen, brittle chips into smaller, finer dust that will spill out of the gullet instead of waiting to be ejected from the gullet when that tooth exits the cut.

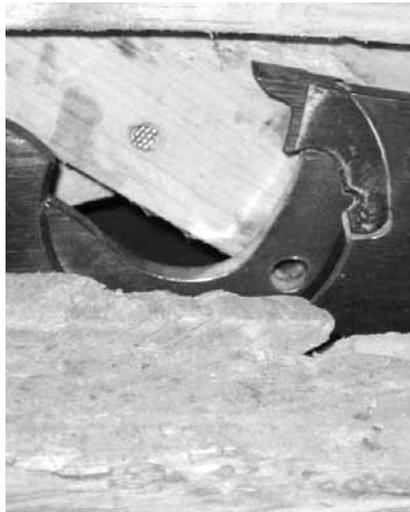
Winter bit with regular shank.

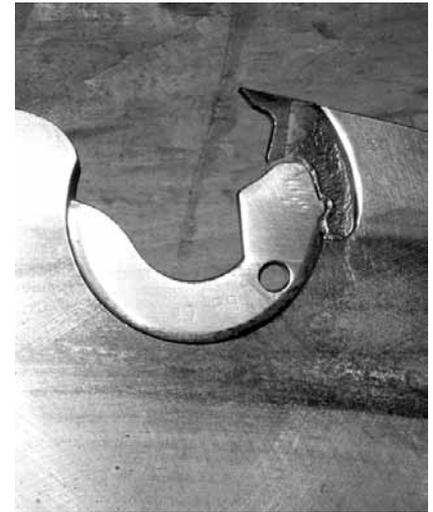
Winter bit with winter shank.

Picture 3 shows that when you combine a winter shank and a winter bit you have the protrusions lining up with each other and forming a rounded gullet that is now smaller than the original gullet. Not only will the saw dust swirl and break up and spill out of that gullet, but because the gullet is smaller, you can't feed quite as fast as you should be feeding to maintain a proper chip size to prevent sawdust spillage.
