SAWMILL FORUM

The Power of Observation

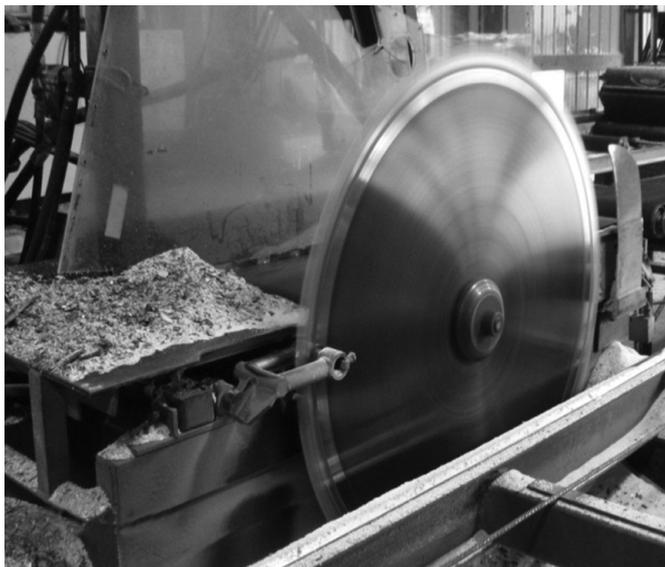
The first thing that I think everyone will notice is how shiny the guideline of the saw is. What does that mean? Of course the sawyer has obviously been trying to hold the saw with the guides. It is safe to say that there is a problem there. Notice that it is the log side of the saw that has the shiny guideline. That means that the sawyer must have a problem with the saw running into the cut (towards the log) and he is trying to hold the saw out enough to prevent it from running in.

I also noticed that the body of the saw is not very shiny. If the sawyer was holding the saw out far enough for it to run out of the log, the body of the saw would rub and get shiny. Since the body of the saw is not shiny I would conclude that the sawyer is only holding the saw with the guides enough to prevent it from running in, but not so much that it tries to run out.

Next we would want to know why the saw is running in. The fact that the body of the saw is not shiny tends to point to a saw that is dished towards the log side. Why is it dished? This is the part that gets hard to predict without closer examination, but here are a few choices.

You can't troubleshoot a sawmill from a photograph, but you can draw conclusions and make some educated guesses.

What else can you tell from the picture? If you look close at the spreader you will see that the top, leading edge is also quite shiny while the rest of it is not. So we know that the spreader is not properly aligned with the face of the log. The spreader should be as close to the log as possible without touching it so that it can gently put a little pressure on the board to keep it away from the saw. Messing with the lead too much can easily leave you with a spreader that is misaligned with the saw, but that won't make it so that it is also vertically out of alignment like this one.

The other thing that I noticed was the pile of sawdust next to the guides on top of the husk. First I see that the sawdust is course enough so I am not worried about an underfeeding problem. But it does tell me that this mill operator does not pay as much attention as he or she should to keeping things as clean as possible. That can very often be indicative of the rest of their preventive maintenance program.

Most of you know I always look at the teeth first because that seems to be the easiest thing to get wrong, which is probably why it's also the most common problem. If the teeth are sharpened high to the log side, the saw will run that way and eventually dish in that direction. I don't know who hammered that saw last, but there are still folks out there who think that a finished saw is supposed to be dished towards the log side. It's not.

Of course there is always the chance that a bad collar is dishing the saw towards the log side. It can happen but it is pretty rare as compared to a bad collar dishing the saw towards the board side. You see, when a collar wears, it usually loses its taper on the fast collar (board side) so that when you tighten the nut it forces the saw over the fast collar so that you now have a saw that is dished towards the board side. On the other hand, it is certainly possible that the collars were not machined properly or that someone replaced one of the collars without making sure that their outside diameters were an exact match. Just because you have two 8" collars, it doesn't mean that they measure exactly the same outside diameter. If one is just a few thousandths bigger than the other, the saw will be forced over the smaller collar when the nut is tightened.

There is also the possibility that something happened to heat the board side of the saw to the point that it would dish the saw towards the log side and the sawyer just hasn't gotten around to getting the saw hammered recently. As shiny as that guideline is, it is a safe bet that it didn't just start happening yesterday.
