SAWMILL FORUM

CASEY
CREAMER

SAW
DOCTOR

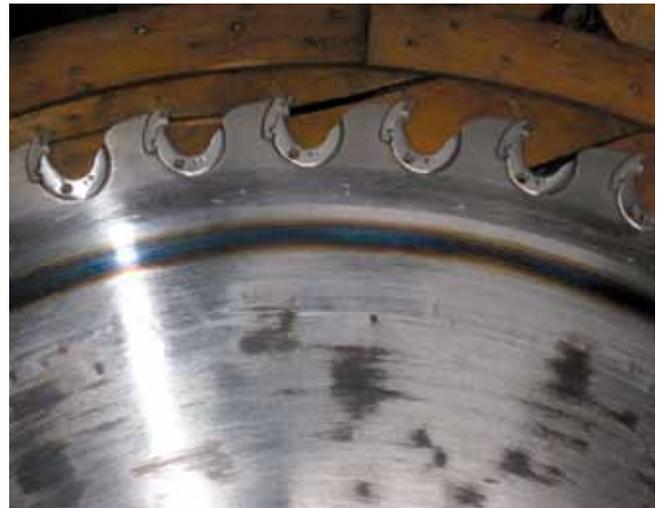
Here is an interesting case I had recently. Check out the picture. Yes, the rim of that saw turned blue right in the guideline.

Upon removing the saw from the crate, I realized that this blue ring was right in the guideline area. That certainly pokes a large hole in the usual jammed sliver theory. Then I noticed something even more unusual: It was equally blue in exactly the same area on both sides of the blade. I say it is unusual because typically, the mark would be a very shiny spot on one side of the blade, with the blue mark on the other side. This is also true when we see those blue spots mentioned earlier.

So, whatever turned this saw blue had to have happened on both sides at the same time. I then searched the saw for any other evidence. I did find a bit of collar metal that I had to remove, which would certainly indicate that this saw sheared the lug pins some time between now and the last time I hammered that saw. I always remove collar metal deposits from any saw I am working on.

But in this case, remember that I observed equal bluing on both sides of the saw at the guideline. And to sort of confirm that finding, I also noted that the saw, although dished some towards the board side, was not nearly as dished as what would be consistent with finding a blue area on one side of the saw.

At that point my conclusion was that the saw must have been heated fairly evenly from both sides at the same time. How could this happen? As many of you know, I do keep records on every saw I have hammered over the past 30 years. I looked at my previous notes on this saw and this mill, and I noticed something very interesting. On a number of occasions I made the notation that saws from this mill seemed to have a lot of guideline wear on both sides. Guideline wear, however undesirable, is not all that uncommon on one side of the saw. It is usually on

Obviously, we have a sawyer here who is running the guides way too tight, which is an understatement. We all know that the term "guides" is not a good description of what the part does. The guides are not supposed to actually guide the saw, but rather just to catch it if it runs too far off line. We all know that you are supposed to have some clearance between the guides and the saw. If the saw lays over to one side it will of course use up that clearance in a hurry, but for the guide assembly to rub both sides at the same time, it could only mean that there was no clearance to start with on either side. I can just imagine how much that saw must have resembled a potato chip while it was running with that much heat on the rim. Fortunately by the time it cooled off and got to my

The first thing you should do if there is blue on a saw is to very gently and carefully sand off the discolored metal. That means removing just the blue without removing any other metal. Well of course that is physically impossible, but if you are very careful, you can remove the one or two thousandths of an inch of blue without taking any more material than you absolutely have to. If you remove too much metal, then it will be a real problem for anyone to put a straight edge on that area and be able to get meaningful readings.

On the other hand, that blued material will no longer move correctly like the rest of the steel when you hammer or roll it. So you have to get rid of it before you try to work on the saw. Once you do, you may notice a large bend in that area on the opposite side from the blue. In this case, both sides were blue so it wasn't a matter of a bend in that area, but there certainly was an enormous amount of tensioning work to be done to restore the body of

Now that I have the saw back into proper working condition, I will try to finish a very important part of the process of fixing saws. I will make sure that I find a way to properly communicate to the right person at that mill what is being done wrong so that they can avoid this problem in the future. They need to realize that if they had gotten this saw just a few degrees hotter, they would be replacing it now. It was way too close to the brink for comfort.
